KANSAS CITY FIRE

A Comprehensive Fire Station Analysis
For the
Kansas City Kansas Fire Department
June 2015

Kansas City Kansas Fire Department Project Narrative:

Date of Inspections: 5/18/15 - 5/20/15

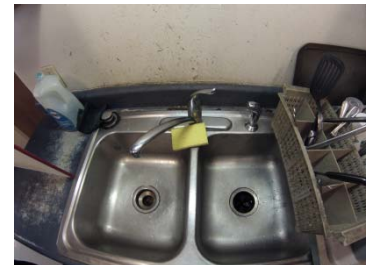
Damage at Kitchen Sink

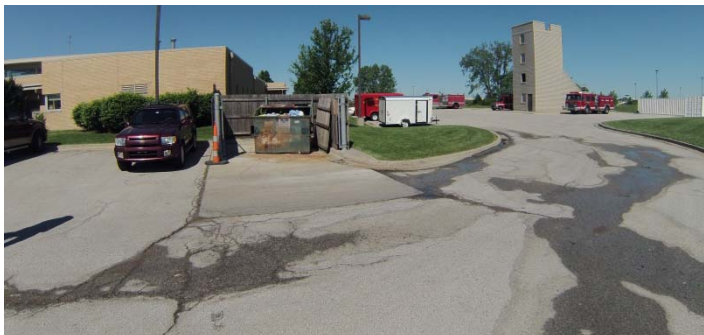
The rear driveway is asphalt in fair condition, needs to have cracks cleaned, filled, and entire surface slurry coated to extend life.

Parking and Drive Asphalt Deterioration

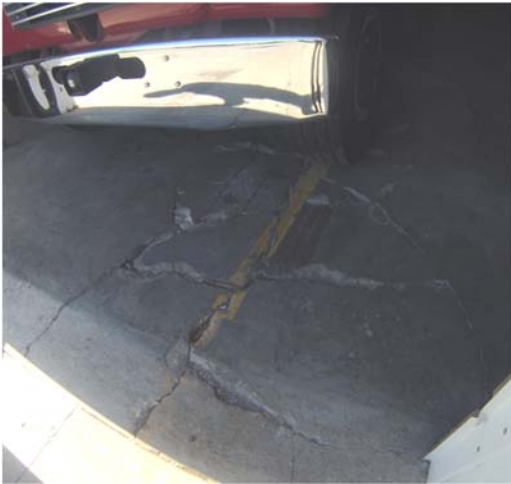
South East corner of tanker bay has significant concrete cracking and spalling occurring, possibly caused by a water leak below slab. The apparatus bay lacks storage space for bay related equipment, the physical training equipment along the north wall is cramped and poorly ventilated. Refrigerators should be relocated out of bay area. North East corner area of bays appears to have roof leak(s).

Significant Cracking in Bay Corner

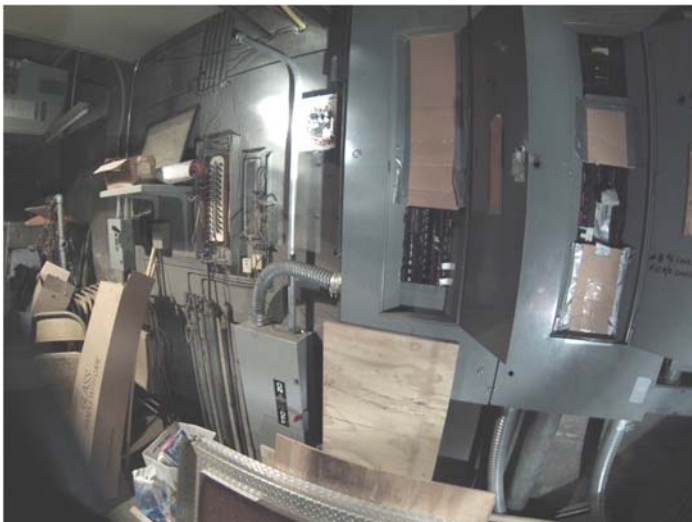
The basement area houses the water heater, HVAC equipment, an abandoned boiler and the main electrical service entrance and panels. The electrical panels are in very bad shape and are a fire hazard because cardboard has been used to cover the circuit breaker spaces. There is a lot of storage clutter also sharing the space making maintenance difficult.

Electrical: Electrical is in very bad shape. The basement panels are a fire hazard and the panels are full. Due to the stations age, repairs and replacement of equipment will be costly and very disruptive to station activities.

Serious Electrical Problems

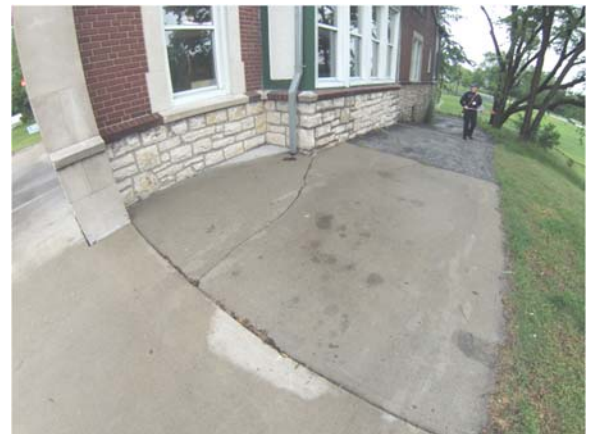
Damaged Concrete Driveway

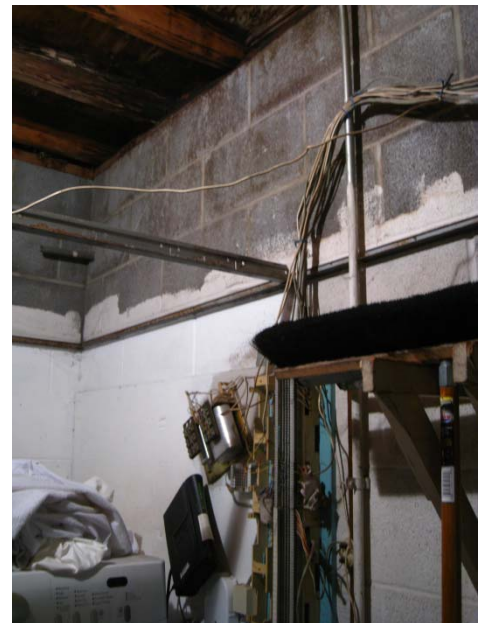
Roof Leak Over Phone Equipment

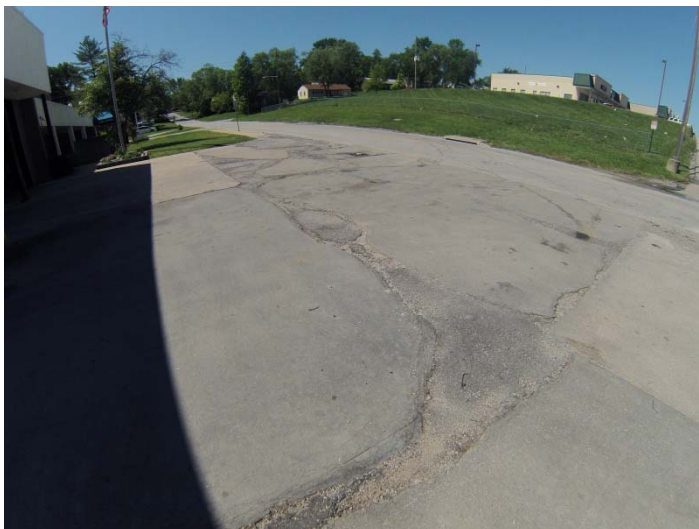
Front Apron Concrete Cracks

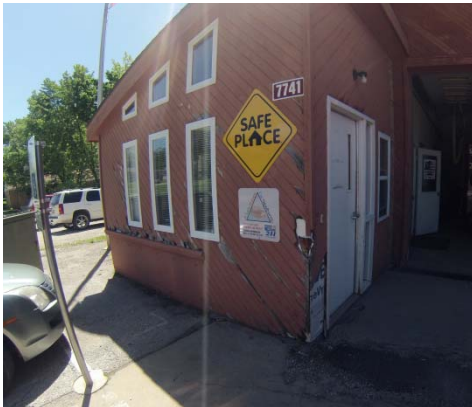
Front Entry Siding Damage

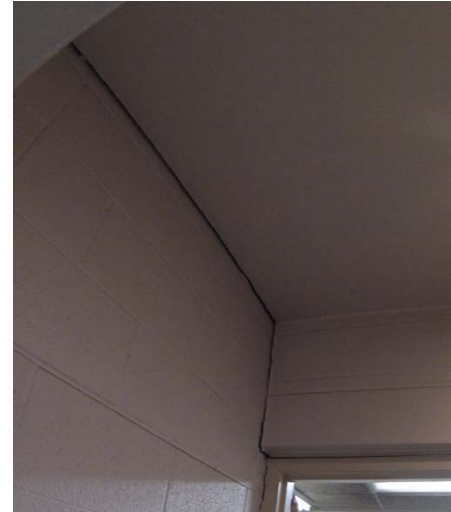
Large Crack in Hallway Masonry

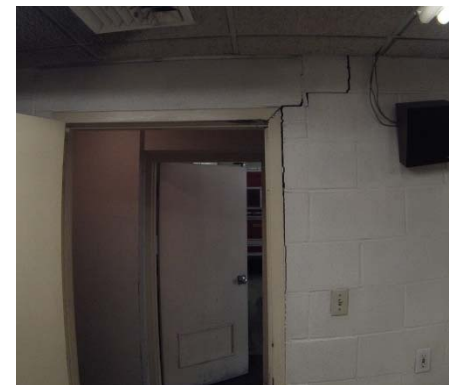
Crack from Bathroom Side of Hall
