Wyandotte County Lake Bridle Trail

RESTORATION PLAN

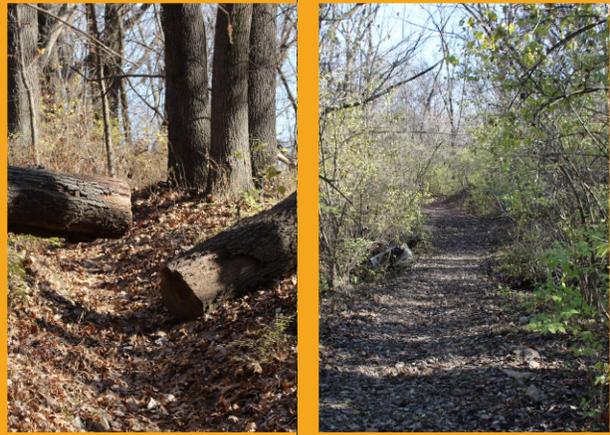
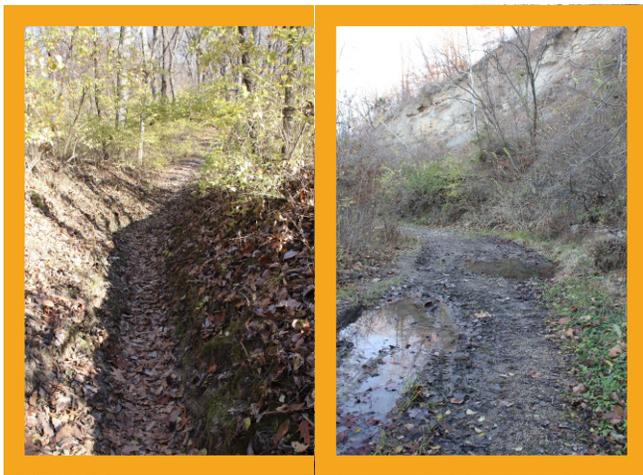
Erosion & Drainage

Erosion of the trail has three primary causes. The first is channelized water on the trail; this causes users to reroute to avoid muddy feet, only expanding the issue. Another cause is use during unfavorable conditions. The path is primarily soil, which is easily displaced if there is heavy use during wet conditions. The final cause is intermittent seeps from nearby springs, which cause large mud pits to span the trail.

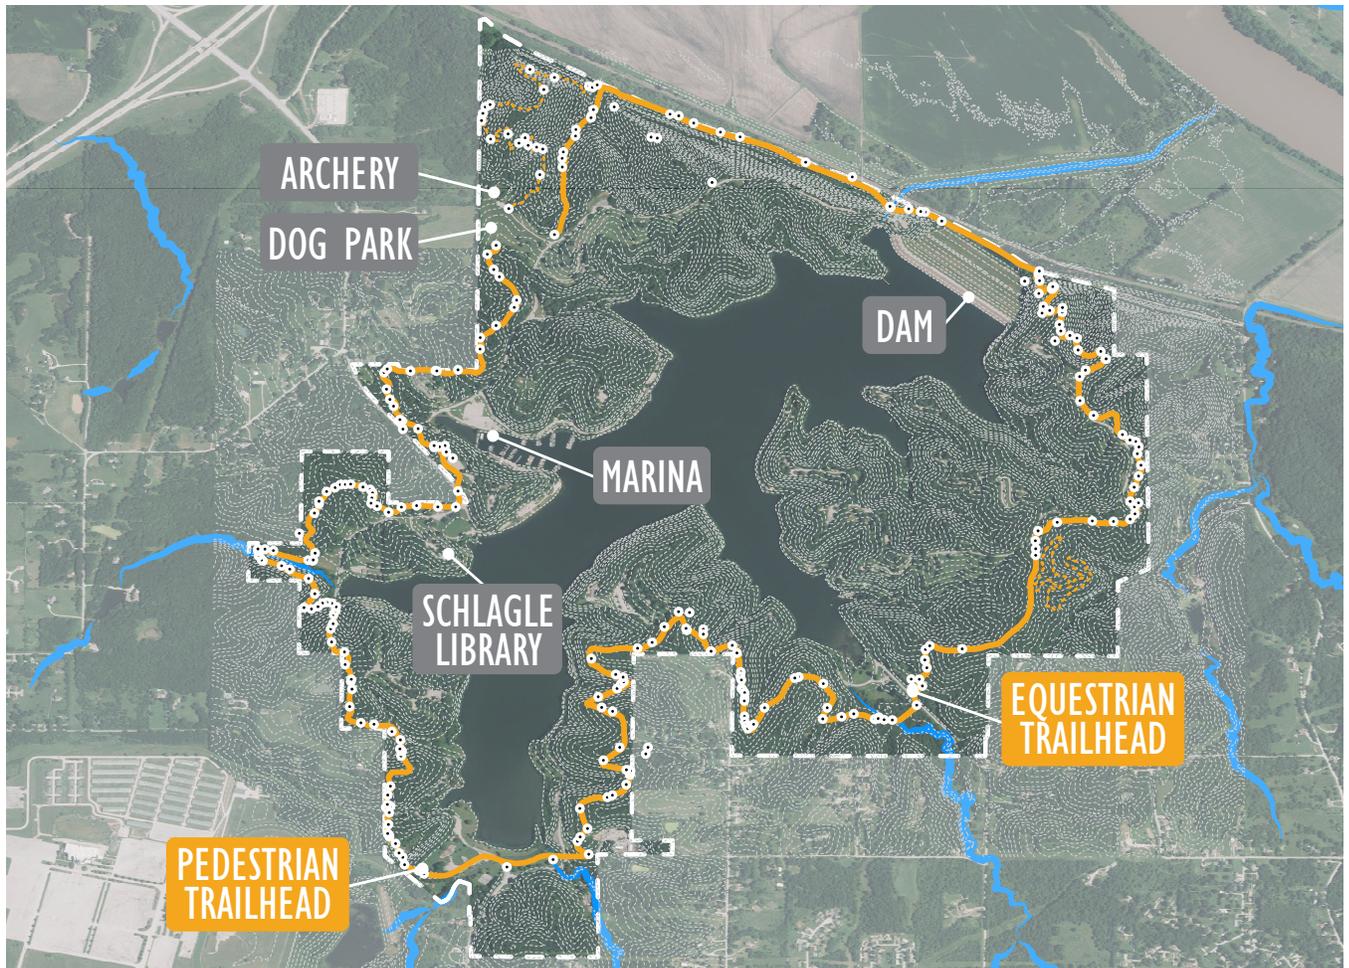
Each dot on the map above represents an issue seen along the trail. Some are as simple as a downed tree, while others represent long-term erosion issues. GPS data was taken for each location, and these points were then broken down into project types described in section 05.

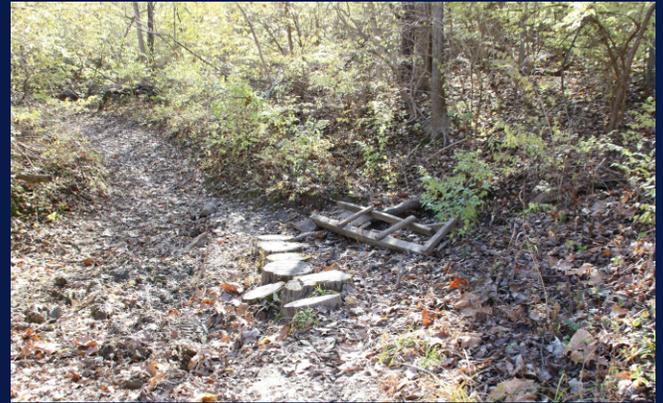
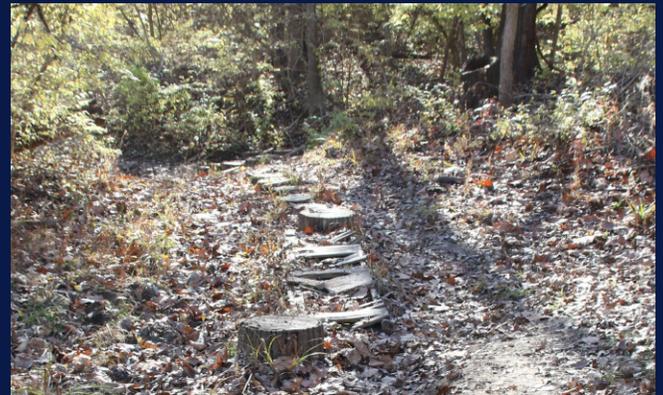
Well meaning trail users have implemented short term solutions. Stumps, logs, even pallets have been placed for users to cross without losing their shoes in the mud.

These types of solutions work temporarily for runners and hikers, but overtime they can sink in or become unstable causing tripping hazards on the trail. Equestrians also have issues with these types of amendments, often routing around them to avoid tripping. As the pallets break up splintering wood and rusty nails have been found in the mud on the trail.

Soft Spots are the result of water ponding on the trail's surface. This can happen for several reasons; inslope, sedimentation, or even natural springs. If this issue is with inslope, a simple regrade to outslope the entire tread section should remedy the problem. In cases of trail sedimentation, or if the trail is unable to maintain an outslope, a wide drain or knick should be added. A knick is a 5-10' wide subtle depression in the relatively flat trail surface that protrudes from the low side—typically having a 15% slope decline to the outer edge to pull water off the trail. A reinforced outlet can be added to keep it from getting clogged or washed out. Either can be done in tandem with a rock layer to keep the surface of the trail dry and allow water to flow off the trail.

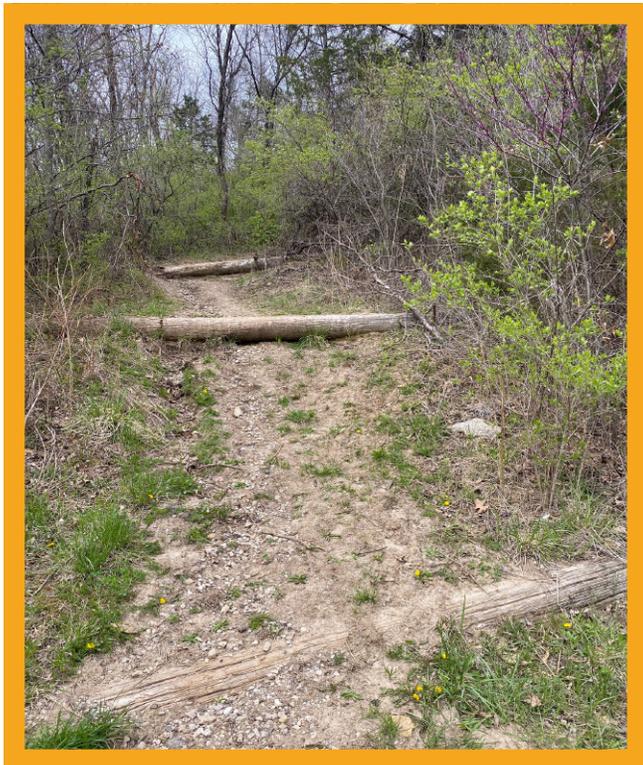
When installed correctly, they are at a 30 to 45-degree angle to the trail; as the water sheet flows down the trail, it hits the waterbar and is pushed off the downslope side of the trail. The issue is that water bars were historically made of wood, which rot and need to be replaced frequently. In other cases, they were undercut, leading to a dangerous sinkhole in the trail or significant tripping hazards. The photo below shows an example from the trail entrance near shelter 6.

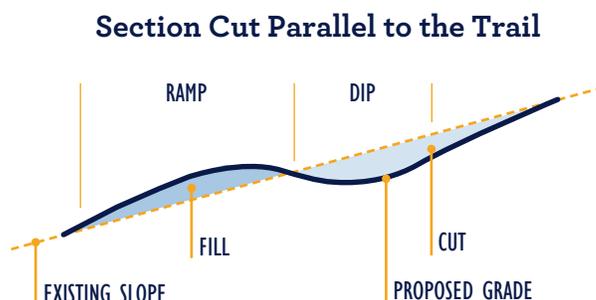
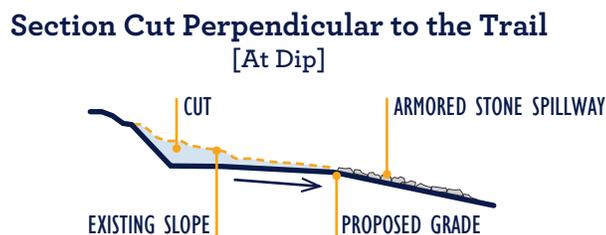
GRADE REVERSAL

These should be installed based on trail slope and optimal drainage locations. This should minimize the maintenance needed, but no trail amendment is without maintenance. Stability should be checked yearly or after extreme washout conditions.

A SHORT DIP FOLLOWED BY A SLIGHT RISE EVERY 20-50 FT

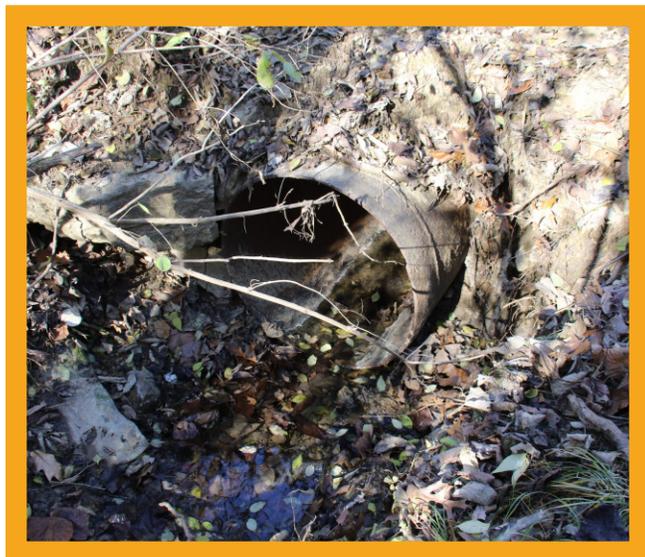
In locations where a drainage channel runs perpendicular to the trail, it can often create a soft spot. The longer it continues to run across the trail's surface, the higher the likelihood of erosion. Mitigation needs to be done on a case-by-case basis. Leaving the trail untouched but monitored is the best course of action for many small drainage channels. In areas low in the watershed, two options are available, depending on the location. A culvert may be the best choice in areas with ample room on either side of the trail. Culverts need space for water to gather before the trail and funnel into a pipe or a small rock culvert and then outlet the other side. If water backs up on either side of the channel, significant erosion will ensue. The surface above the culvert can be thin and may need regular maintenance.

The other option is low water crossings made of gravel and cobbles. A trench carved out and filled with large cobbles, then topped with gravel, without fines, will allow the water to move freely through the trail. This will need armoring and regular maintenance in seasons of high rainfall.

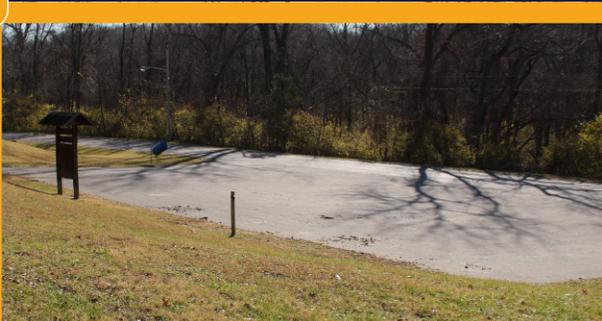
A

- A** Soft Spot: Consider crushed fines as an amendment to the beginning of the trail. High traffic and heavy use will continue to displace soil.
- B** Entry Erosion: Significant cut at trail entry, mitigate at the entry point, and supplement with rolling dip if needed.

- C** Regrade: Trail narrows due to erosion. Consider fill and crushed fines to stabilize the area and divert water off the trail.
- D** Channelizing: Regrade with rolling dip.

- E** Regrade: Erosion likely due to use in wet conditions. Regrading is needed for proper sheet flow to minimize future soil displacement. Add a knick to reduce ponding.

- H** Entry Erosion: Consider crushed fines as an amendment to the beginning of the trail. High traffic and heavy use will continue to displace soil.
- I** Switchbacks: Created by the trail runners in recent years in reaction to the heavily eroding fall line trails used to navigate the northeastern section of the park. For equestrian users, they are proving to be a technical challenge, with narrow trailbeds and tight corners. Stabilization will be vital in maintaining this location through native vegetation and rock armoring.

- J** Stream Crossing: Consider the addition of geotextiles to stabilize banks.

Dots seen on the map to the right identify an issue caused by drainage or erosion. Some areas are minor and are only noted for continued monitoring; others relate to long-term management and restoration projects to create more sustainable trails.

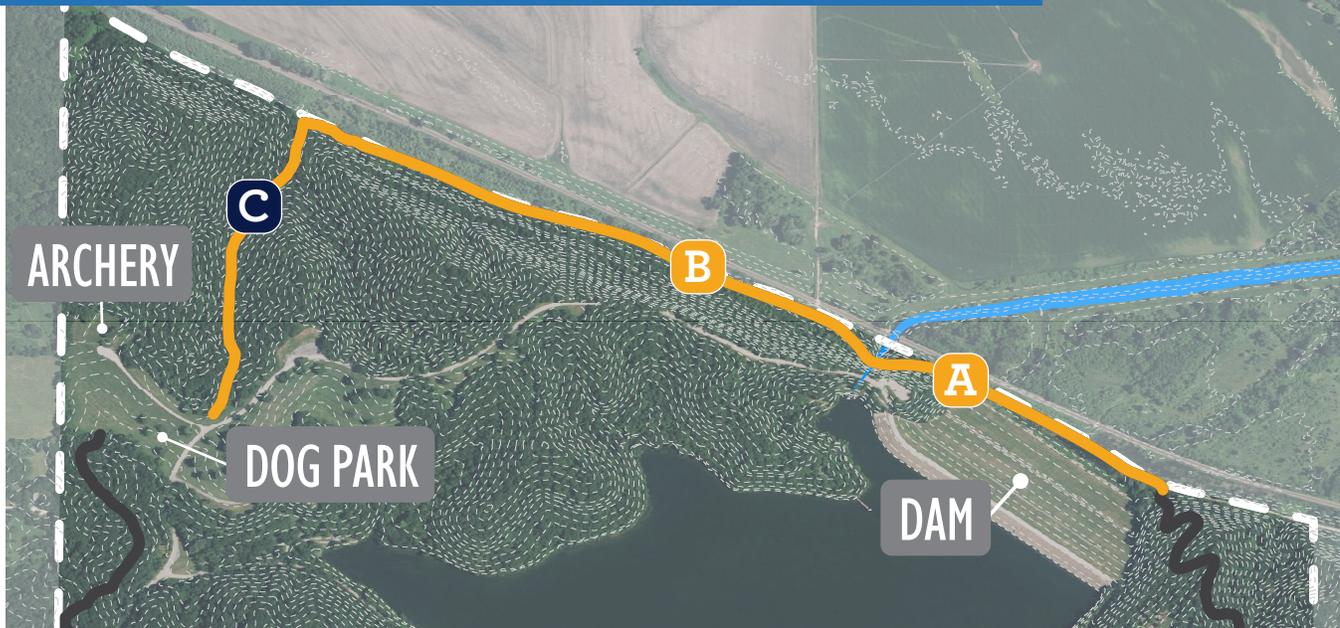
NORTH | Dam to the Leash Free Dog Run

The northern quadrant of the trail following the back of the dam suffers from significant standing water with areas that remain soft all year round. Restoration in this section of the trail breaks down into three major projects.

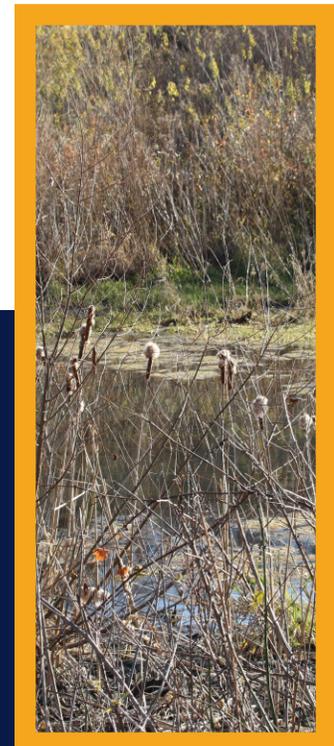
Projects A & B contain similar conditions; the trail remains soft year-round, with water visibly pooling around the trail.

A Consider resurfacing with gravel to maintain emergency and maintenance vehicle access, directing water drainage from the backside of the dam into the improved wetlands described in the amenity updates.

The trail can be used currently, but the stream channel is beginning to meander within the valley, and bank restoration may be needed for long-term sustainability. A geotextile or similar armoring method partnered with deep-rooted native vegetation may be installed to keep the trail usable in high water conditions.

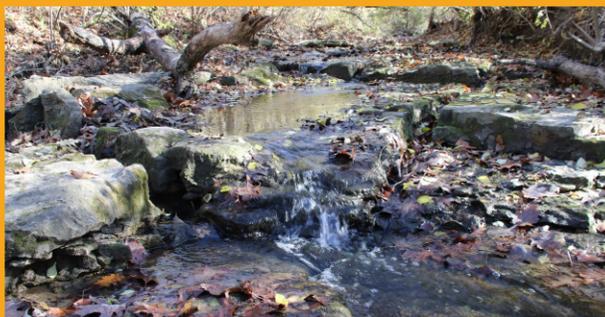
Several locations require significant restoration due to erosion and drainage concerns, as noted by the many projects listed below.

- A** Soft Spot: Consider crushed fines as an amendment to the beginning of the trail. High traffic and heavy use will continue to displace soil.
- B** Soft Spot: Consider crushed fines as an amendment, highlighting the spur down to shelter 14.
- C** Channelization: Trail narrows due to erosion. Consider fill and regrade with rolling dips to stabilize the trail and reroute surface water flow.

- D** Drainage Crossing: Water from an upstream detention pond is causing significant erosion and soil displacement. Consider a partnership with neighbors to create another wetland detention structure with a piped overflow beneath the trail.

- E** Fencing and vegetative overgrowth behind the marina storage cause significant narrowing of the trail. Short-term, remove shrubby vegetation. Long-term, fencing for the maintenance area could be shifted south to allow better access.

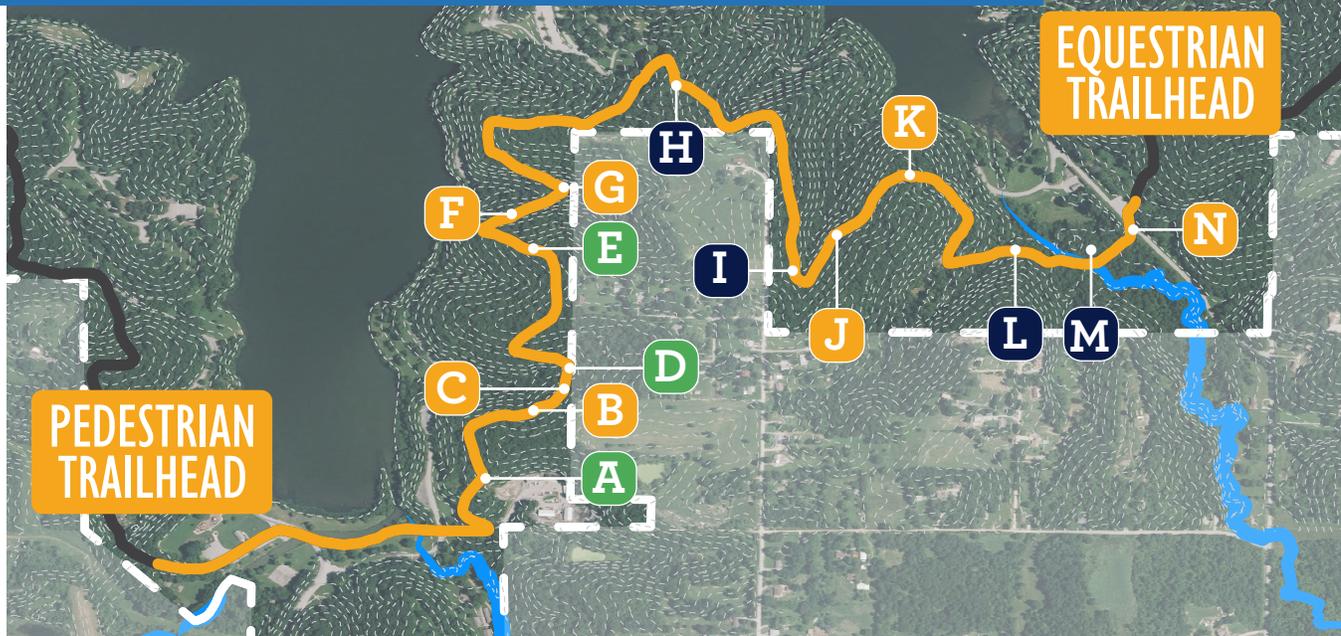
SOUTH | Pedestrian to Equestrian Trailhead

Between the two existing trailheads, the southern section of the trail is the least traveled. Many users are making out-and-back trips north from either trailhead and turning around when they encounter unfavorable conditions on the trail.

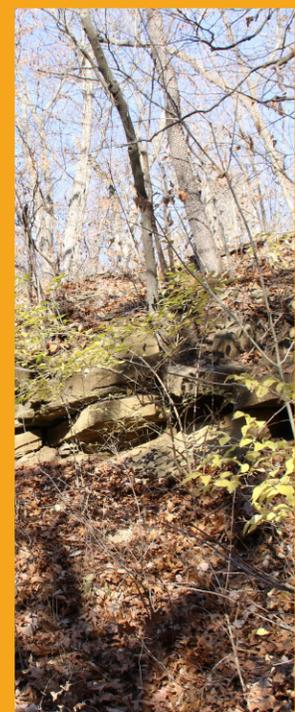
There are several locations with mud liable to remove your shoes within this section. The projects seen to the right aim to remedy this and other erosion issues.

- A** Replant: Remnant trail, replant with natives to mitigate the current confusion in locating the trail.
- B** Soft Spot: Current crossing solutions provided by trail users are inadequate. Stumps, logs, and pallets need to be removed. Regrade trail with knick.

- C** Channelization: Fill and regrade with modifications to outlet water.
- D** Replant: Remnant trail, replant with natives to mitigate the current confusion in locating the trail.

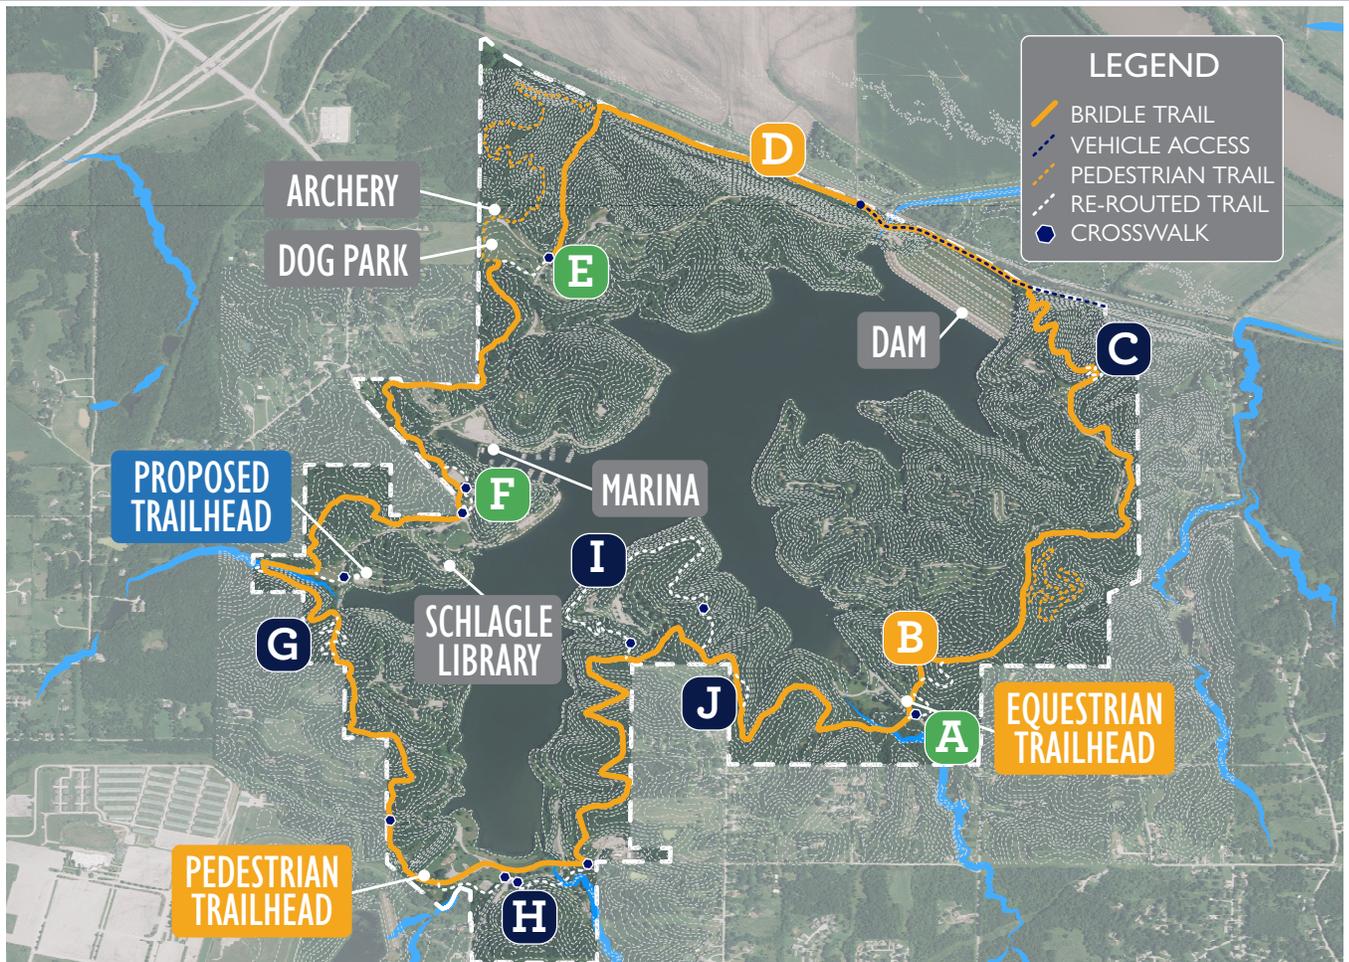
- A** Perpendicular crossing at County Lake Park Rd., rerouting also allows users to stay out of vehicular traffic.
- B** Reroute to address erosion issues.
- C** Reroute to address erosion, creating switchbacks to navigate the slope.
- D** Defining the primary route for the Bridle Trail repair to keep this accessible for vehicles for future maintenance.
- E** To avoid conflict within the dog park and direct users south to the trail.

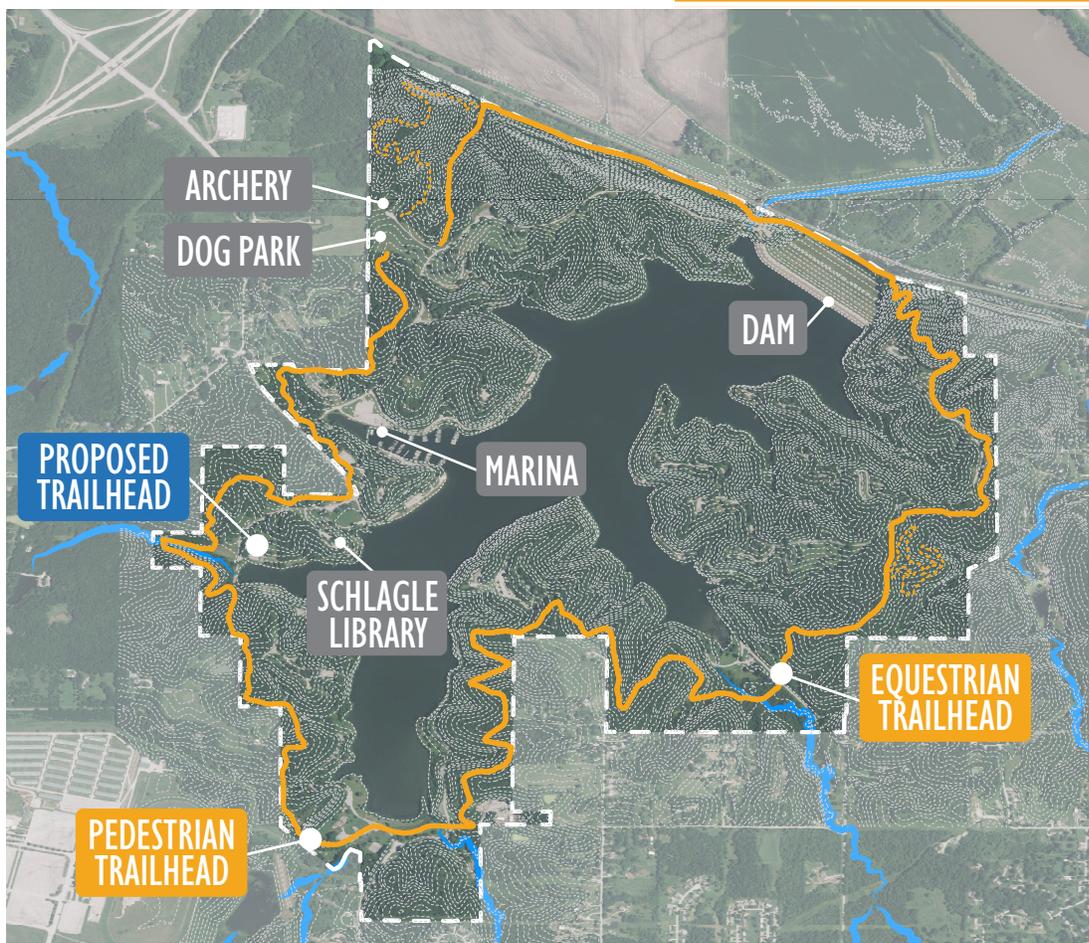
Proposed Equestrian Trailhead located at shelter 6, with a pull-through gravel parking lot. This western location has convenient access to water, an existing restroom, and an easy trail connection. It also gives equestrian users a new way to experience the park by bringing them closer to the lake. This would be used in tandem with the existing equestrian trailhead.

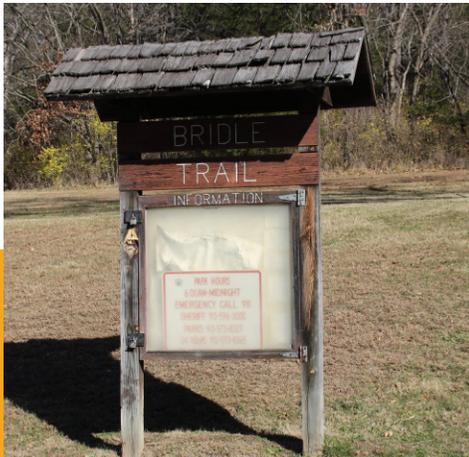
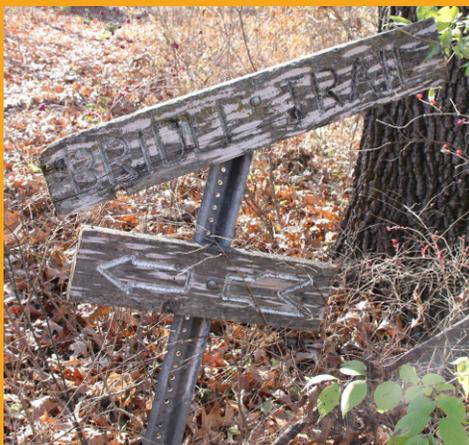
Current Conditions

Signage is lacking throughout the park and is almost nonexistent along the Bridle Trail. There is limited information provided at either existing trailhead, and users are left to infer where to begin their journey.

Some of the trail entrances are marked with signs that vary greatly in legibility. Some are decaying, and others are completely overtaken by vegetation.

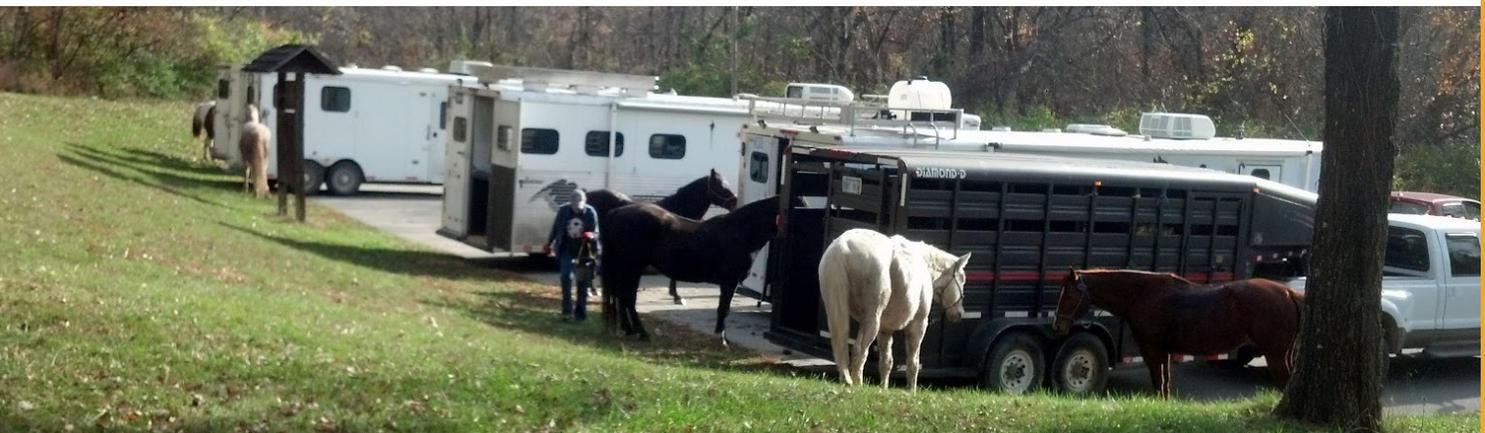
Equestrian Trailhead

Updates to the **Equestrian Trailhead** would begin with creating a larger pedestrian space away from the parking lot. The space will be defined by hitching rails, a multi-use drinking fountain with a frost free spigot, picnic tables, and a trailhead kiosk.
