KANSAS CITY FIRE

A Comprehensive Fire Station Analysis
For the
Kansas City Kansas Fire Department
June 2015

Kansas City Kansas Fire Department Project Narrative:

Date of Inspections: 5/18/15 - 5/20/15

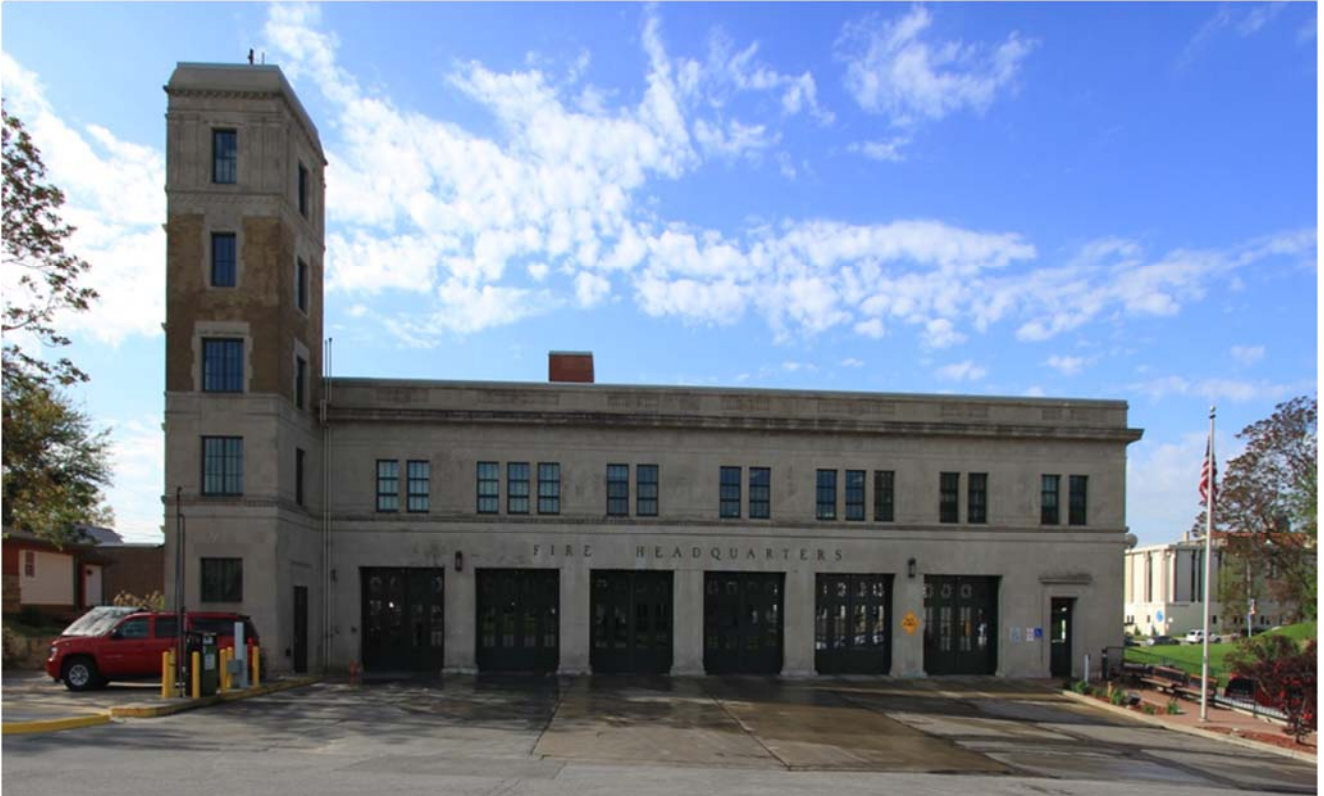
Fire Station 1 - Headquarters
Photo by KCKFD Bill Blackwell

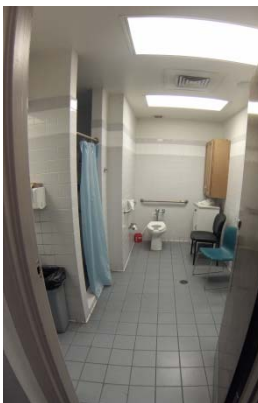
Bathroom

Plumbing: Restrooms have been updated, core plumbing in walls and drains are an ongoing issue for breaks and leaks.

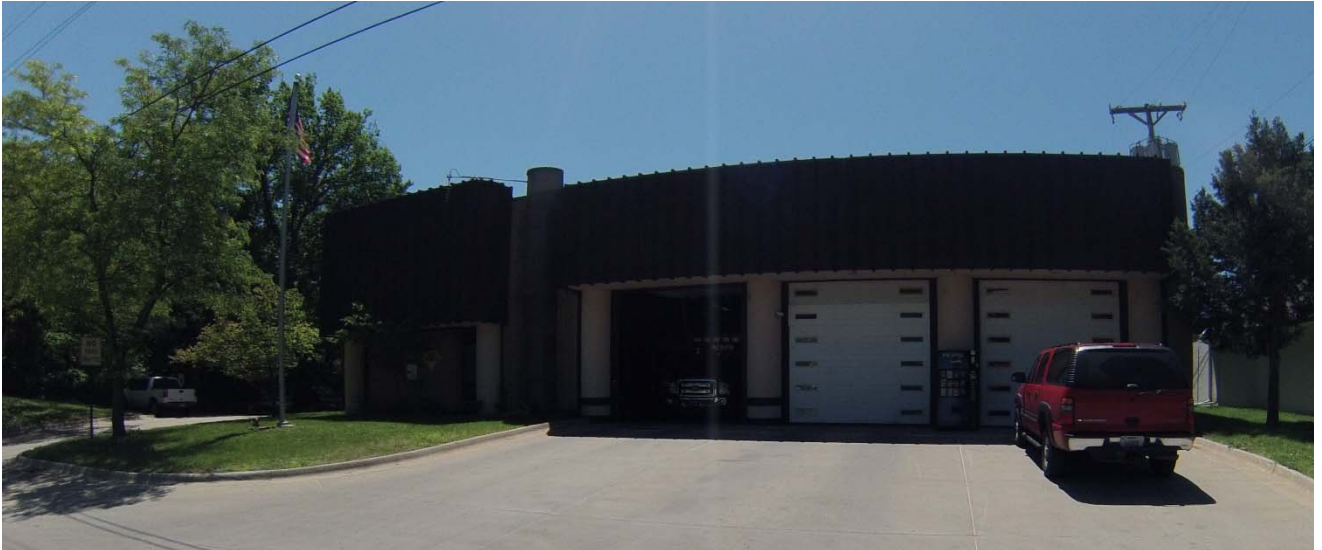
Front Elevation of Station

The front apron and rear aprons are concrete and are in bad shape, lots of spalls and patches. All aprons need to be replaced

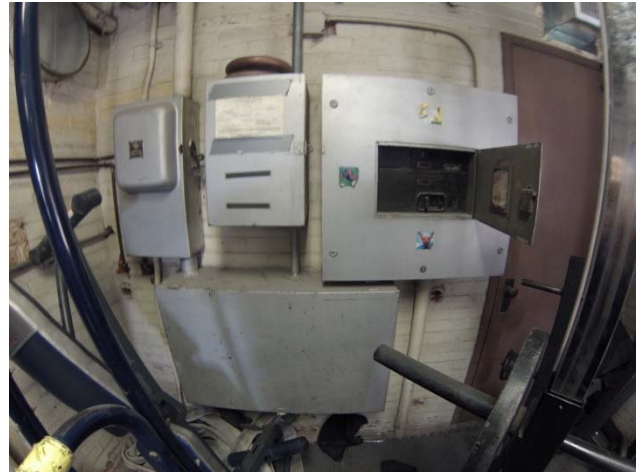
Very Old Electrical Gear

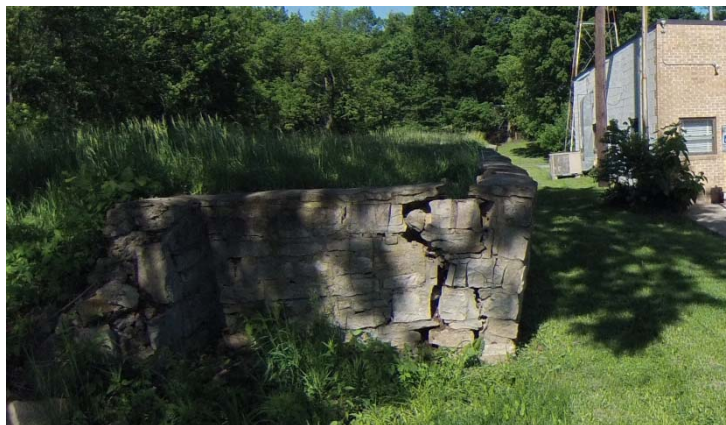
There is a stone retaining wall along the South side of the station which is on station property and is collapsing due to a large tree root growth and age. This wall could be removed and have the site re-graded to ease slope of adjacent property. The adjacent lot has become difficult to maintain due to this walls condition.

Structurally collapsing Retaining Wall

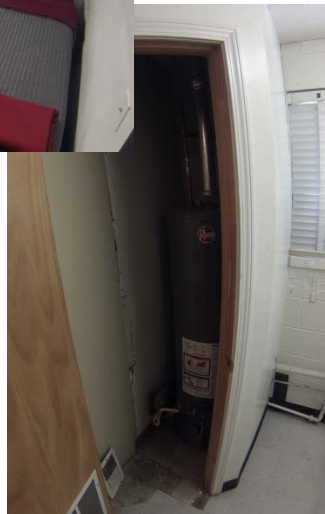
Dorm Bath Water Heater

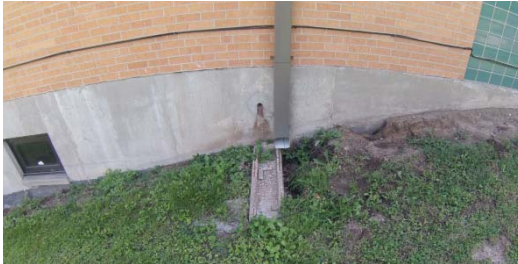
Downspout Erosion

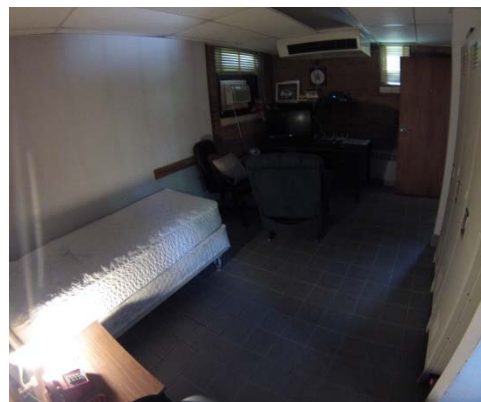
Captains Dorm

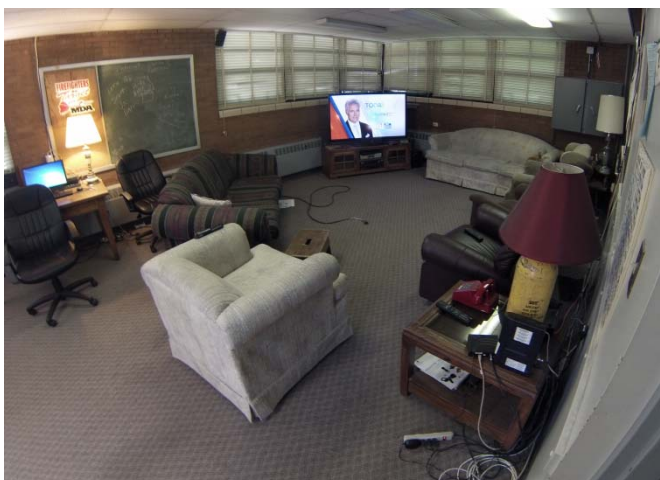
Day Room

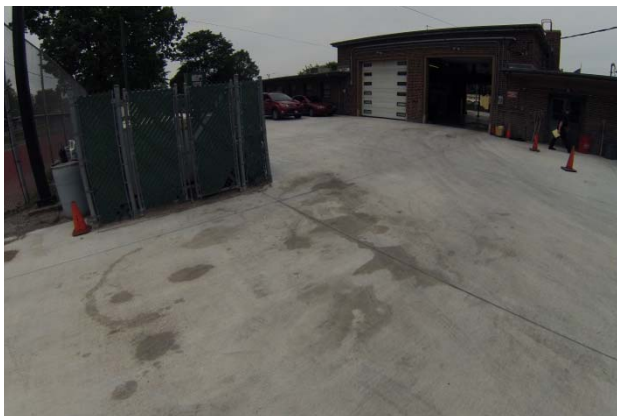
The front apron is in the process of being replaced, the rear apron has already been completed.

New Concrete Rear Apron

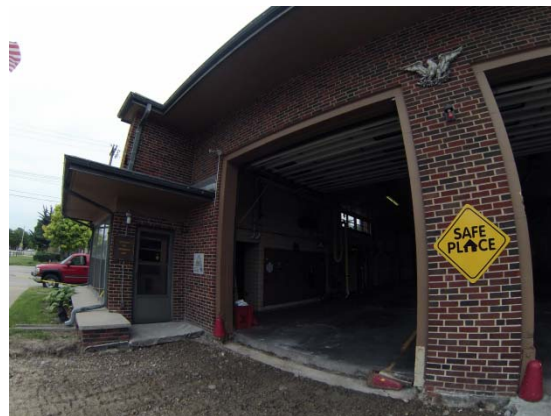
New Concrete Front Apron

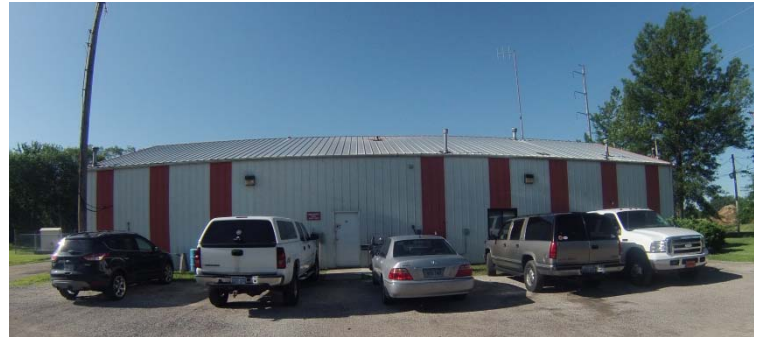
Rear of Station & Staff Parking

Rear driveway is gravel in good condition. The culvert drain pipe is crushed at drive entry due to wide turns and narrow entry width.

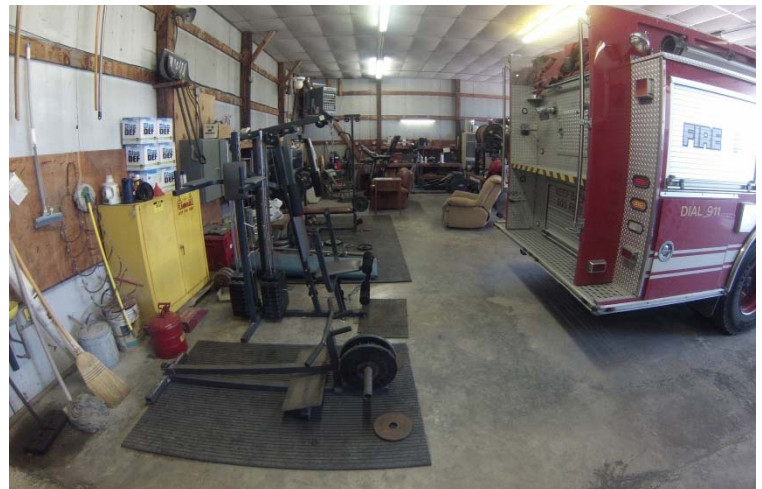
South East corner of tanker bay has significant concrete cracking and spalling occurring, possibly caused by a water leak below slab. The apparatus bay lacks storage space for bay related equipment, the physical training equipment along the north wall is cramped and poorly ventilated. Refrigerators should be relocated out of bay area. North East corner area of bays appears to have roof leak(s).

PT Equipment and Lack of Storage

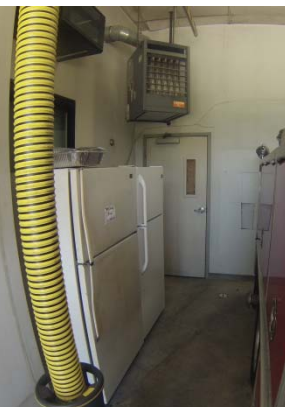
Refridgerators in Apparatus Bay

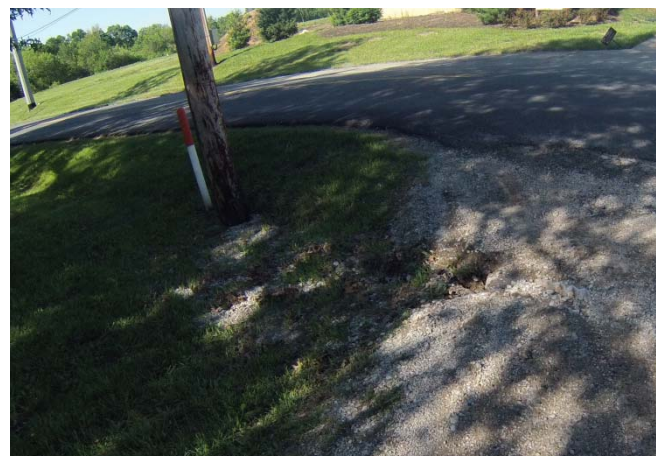
Crushed Culvert at Rear Drive

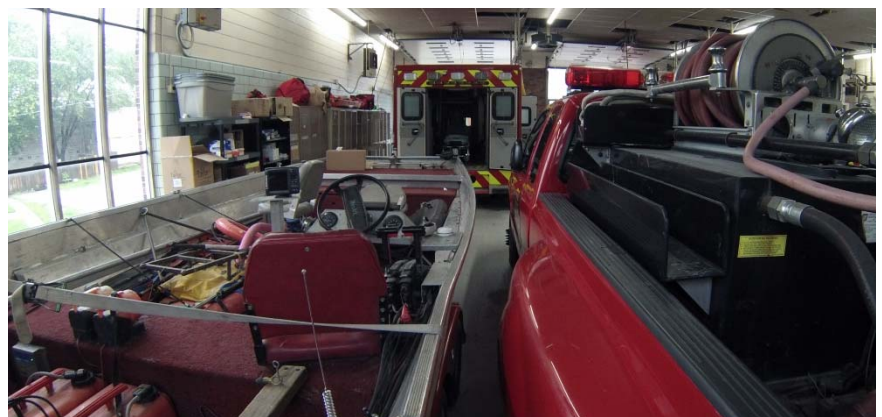
Apparatus Bay Equipment Storage

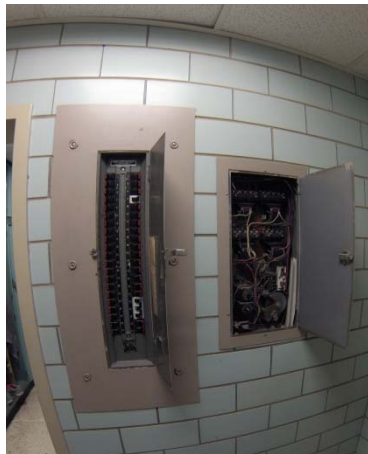
The basement area houses the water heater, HVAC equipment, an abandoned boiler and the main electrical service entrance and panels. The electrical panels are in very bad shape and are a fire hazard because cardboard has been used to cover the circuit breaker spaces. There is a lot of storage clutter also sharing the space making maintenance difficult.

Electrical: Electrical is in very bad shape. The basement panels are a fire hazard and the panels are full. Due to the stations age, repairs and replacement of equipment will be costly and very disruptive to station activities.

Very Old Electrical

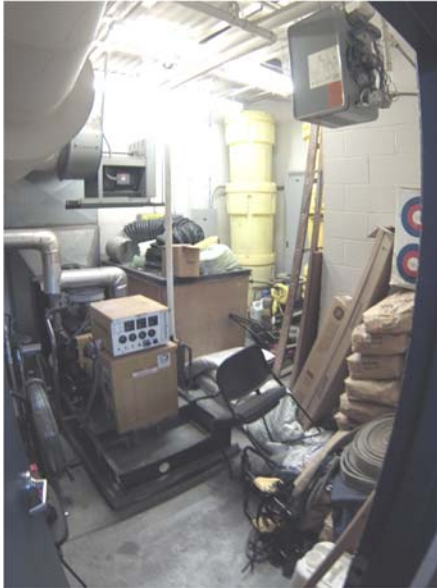
Utility Closet and Overflow Storage

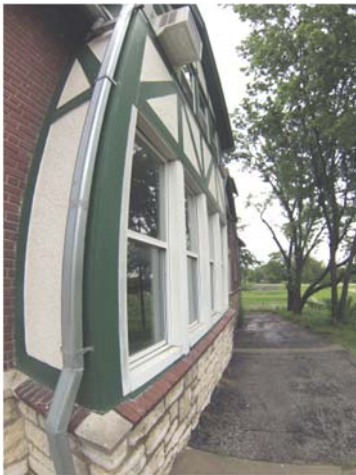
App bay lacks storage space for bay related equipment. The East facing windows are leaning in, all windows should be replaced.

East Bay Windows

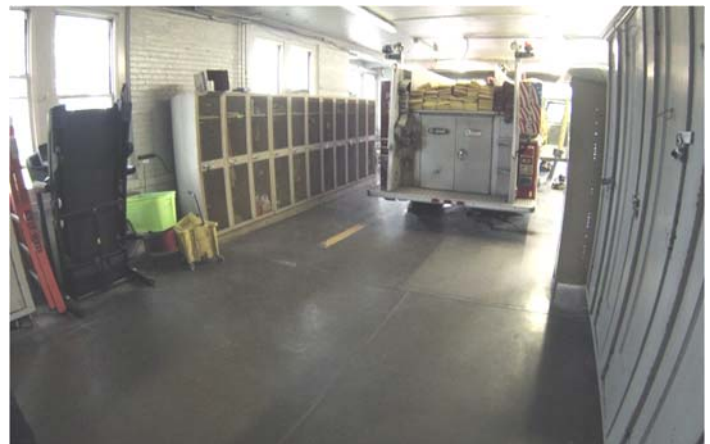
Bay Storage

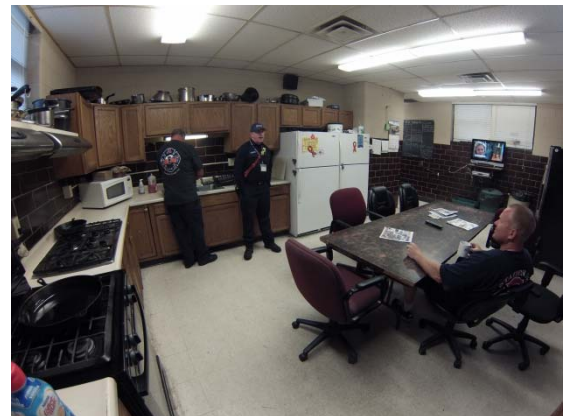
Old historic style - residential scale appliances, wood cabinets with plastic laminate counter tops. The cabinets are worn out and the base of the sink cabinet has rotted away. There are glazed block walls with some plaster partitions and ceilings are 2x4 suspended grid ceilings with fluorescent light fixtures.

Kitchen

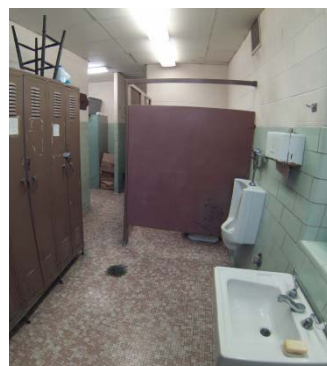
The bathroom has ceramic tile floors and glazed block walls but is worn out and needing an upgrade.

Bathroom

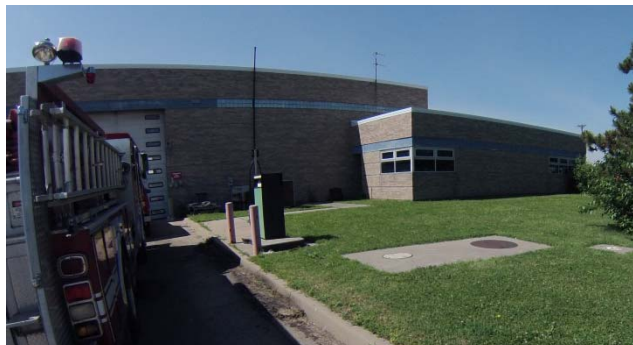
Rear of Station & Abandoned Fuel Island

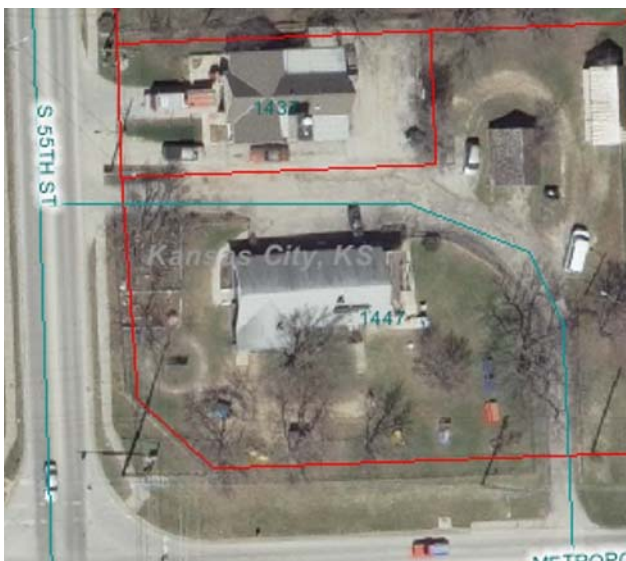
Site Photo

The front apron is concrete in fair condition. The surrounding driveway is asphalt in very poor condition. Landscaping is lawn.

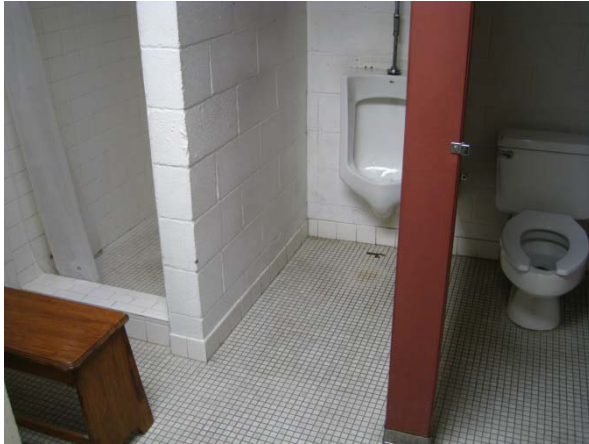
Bathroom

Plumbing: Core plumbing in walls and drains are an ongoing issue for breaks and leaks. It can not be updated without significant cost and disruption.

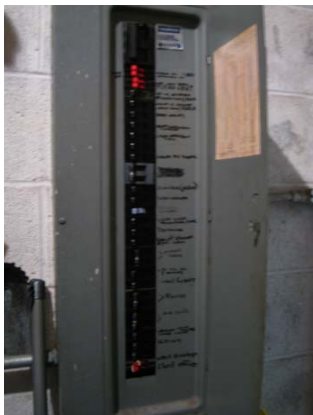
New Electrical Panel

Electrical: Very old, one panel has been replaced, but overall can not be updated without significant cost and disruption.

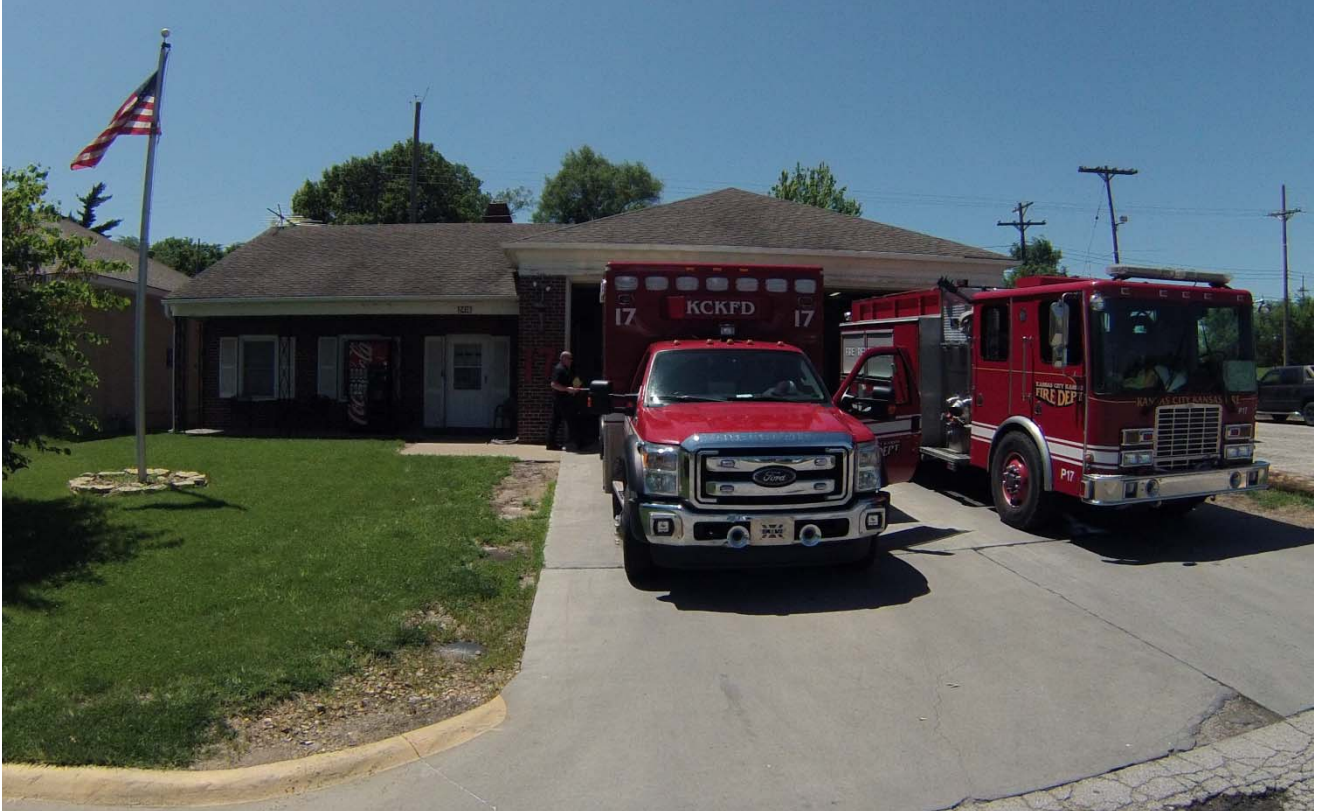
Fire Station 17

This station is in good shape considering its age. The crews take pride in their station and keep it neat and clean. Storage is an issue throughout. Improvements and repairs will be costly and disruptive due to the station's age and small size. It also will have asbestos, mold, lead paint and possibly PCB's in old ballasts contributing to the expense for improvements.

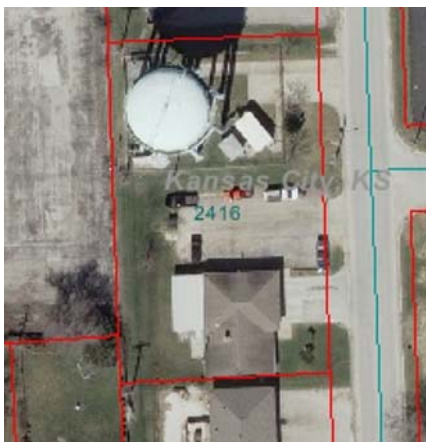
Site Photo

The front apron is in decent shape but the street asphalt is crumbling and in need of replacement.

There is an ADA designated parking space but the parking area is in very poor condition. **See ADA.**

The side parking lot is crumbling asphalt and is in poor condition and access to trash dumpsters for pick-up is tight.

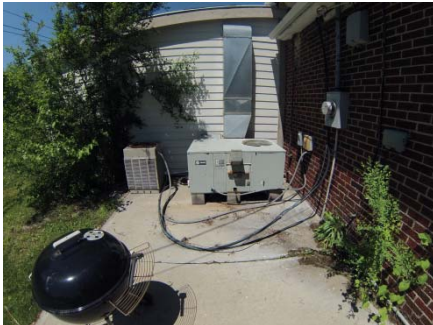
HVAC: Dorms have a ground mounted package unit with exposed ductwork, station has a small split system air conditioner with unprotected refrigerant lines. This equipment takes up space on the small back patio.

Unsupported HVAC Cable

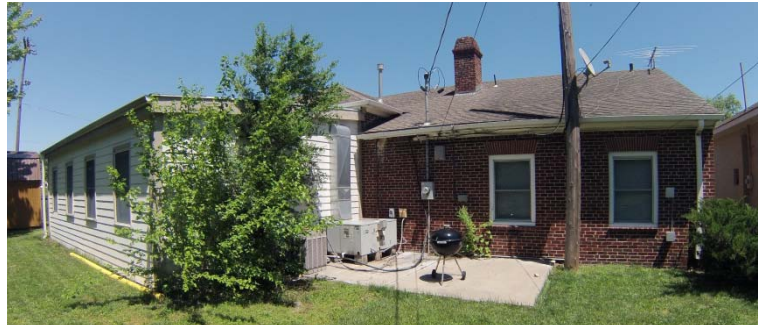
Rear of Station No Patio Access

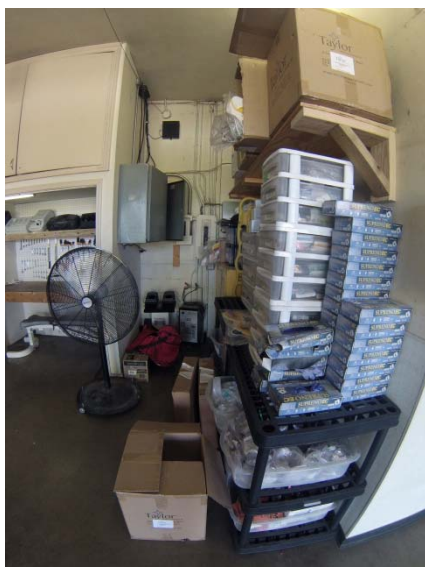
App bay lacks storage space for bay related equipment and EMS supplies, No PT equipment was observed in this station.

EMS Storage In App Bays

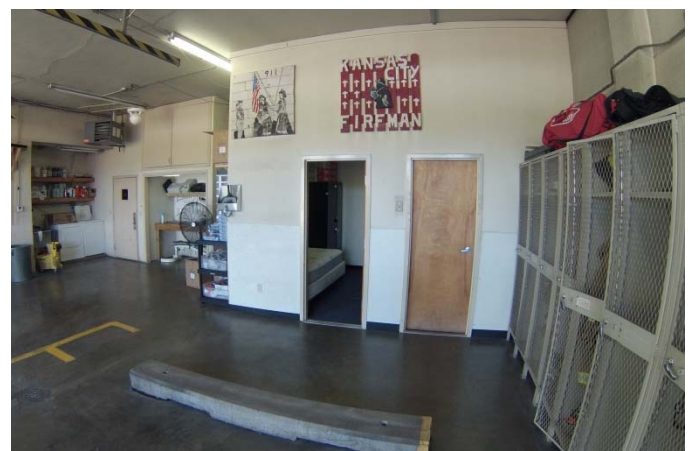
2 Dorms In App Bays

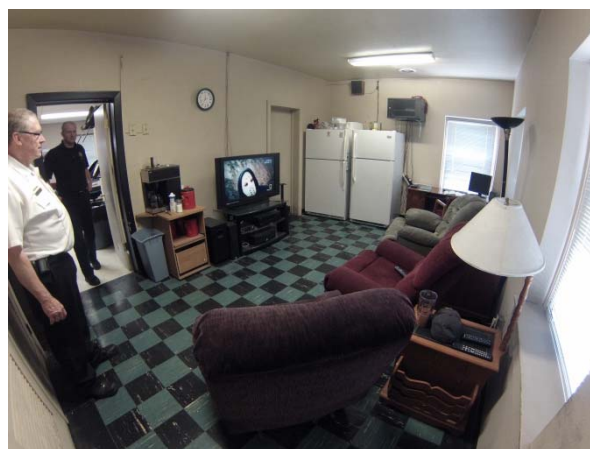
Day Room with Extra Refrigerators

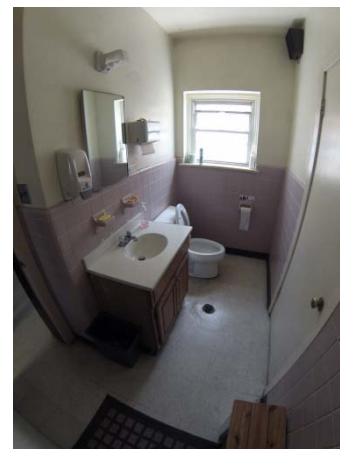
Individual Use Bathroom

Plumbing: Pipes and waste lines are old and difficult to maintain, repair or replace. Improvements would be costly and extremely disruptive. Single restroom with 1 toilets, 1 sink and vanity, 1 tile shower. Restroom can only be used by one member at a time. No female space.

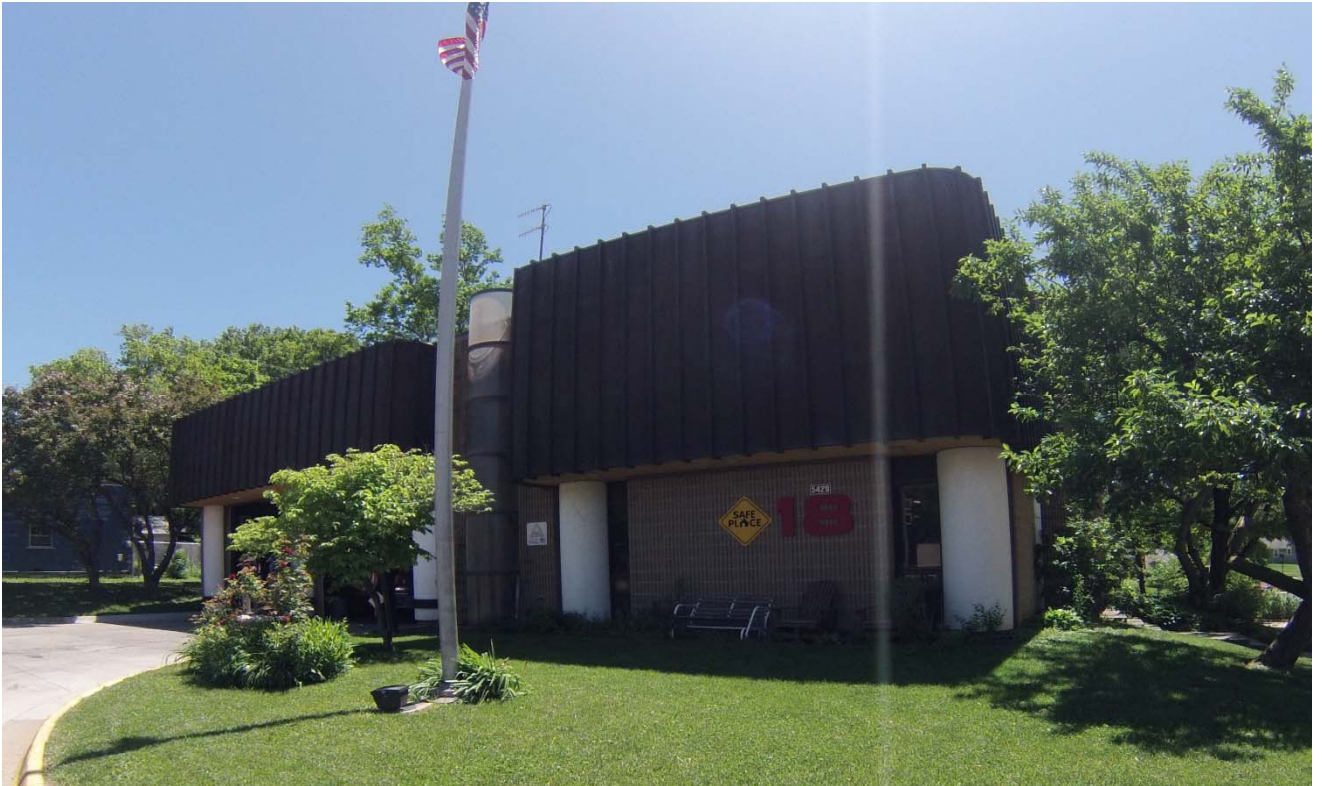
Fire Station 18

Station is in fair shape but needs a thorough cleaning. It is structurally sound, no significant damage or cracks observed. Storage is an issue throughout the station. **Station does not comply with ADA, NFPA, or IBC.**

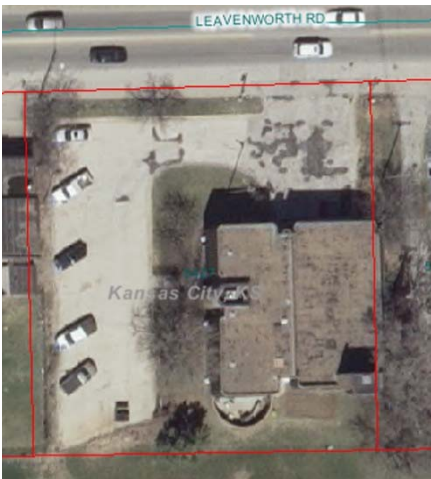
Site Photo

The front apron is concrete and is in fair condition, side parking lot is also in pair condition.

No ADA parking observed. **See ADA.**

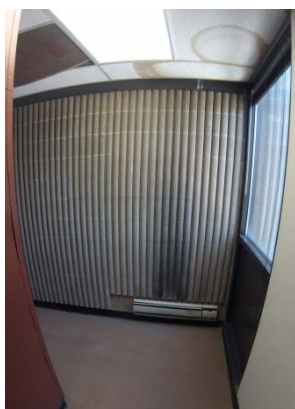
Locker area base heaters do not work and show burn marks on walls above them.

Scorched Wall at Radiant Heat

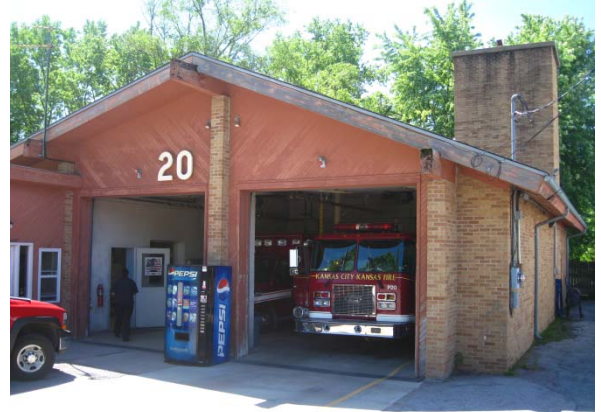
This station is brick masonry walls, with wood beams and wood joist framing. All of the wood is in very bad, failing condition. The structural beams have rotted on the exterior and all wood fascia and trim paint has degraded and the wood is now rotted and has to be replaced. The East beam is twisting along the depth of the apparatus bay contributing to its weakness. The front of the station has a small "watch room" area projecting out from the front of the station. The exterior wood slats have rotted and exposed the construction paper building wrap and the framing beneath. The masonry wall on the East side has an "infill" panel that has a large crack exposing the core of the wall to the elements. There are no patios, porches, or areas for the crews to Bar-B-Q outside.

Front of Station with Raw Wood Fascia and Beams

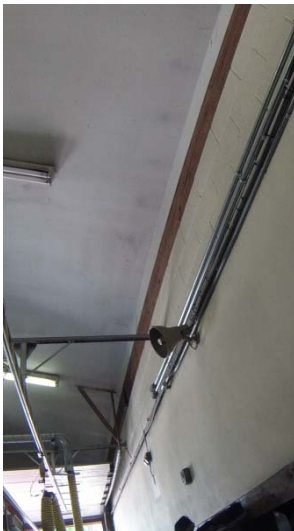
Wood Beams Twisting

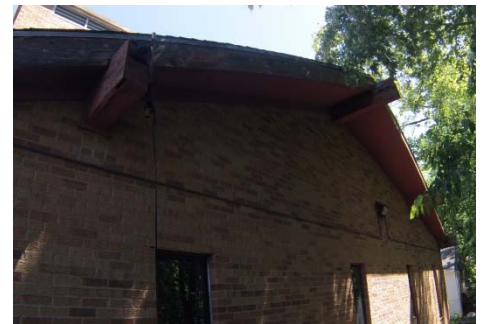
Rear of Station with Raw wood Beams and Fascia

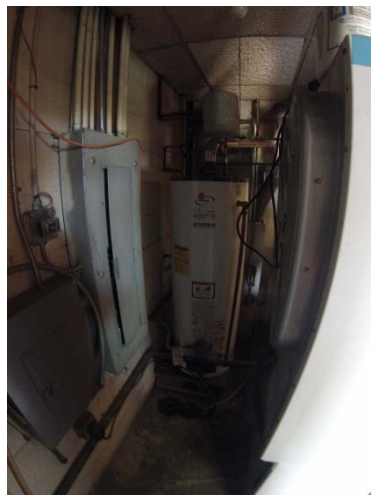
All utilities share a recessed space near the kitchen area of the apparatus bay. The electrical panels are old and inaccessible, and are adjacent to the gas water heater and small furnace. There is an "apartment style" stacked laundry washer and dryer in front of these items. There was one small compressor unit to a split system air conditioner that is old and undersized. The entire plumbing, mechanical and electrical systems would be very difficult and costly to maintain, repair, and/or replace due to station age and construction.

Cramped Outdated Utilities

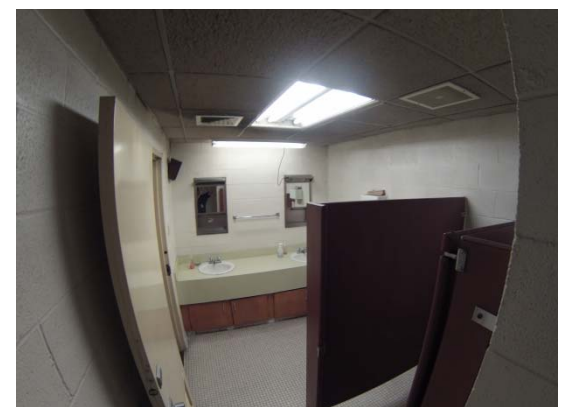
Bathroom
